Protection of Rack Stored Exposed Expanded Group A Plastics with ESFR Sprinklers and Vertical Barriers

Final Report

UL LLC

Issued: June 28, 2013

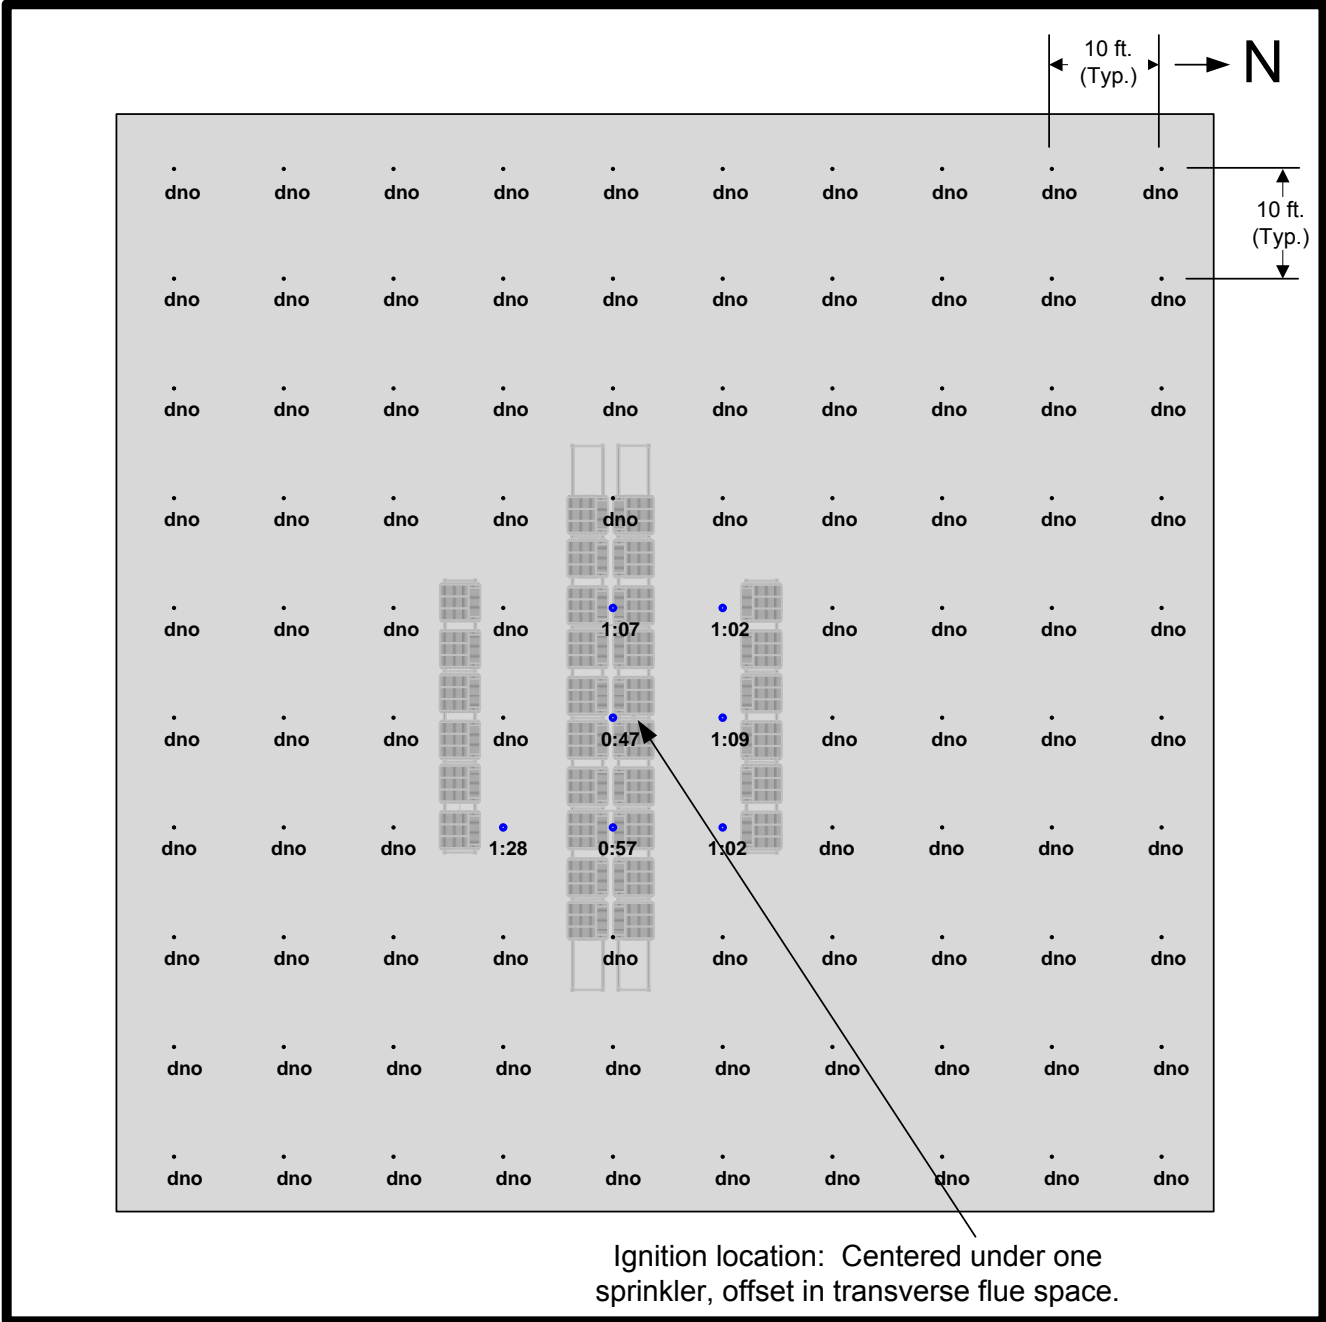
Figure 16 Operation Sequence of Sprinklers (minutes:seconds)

The ignition of the test commodity created a fire that grew very rapidly both vertically and horizontally. In the test, the operation of the first sprinkler occurred at less than 1 minute after ignition. A total of 7 sprinklers operated with the last sprinkler operating at 1 minute 28 seconds after ignition. The fire breached both of the vertical barriers located immediately to the east or west of the ignition; however, the barriers were observed to inhibit horizontal fire travel to the extremities of the main test array. Where breaching of the vertical barriers occurred during the test, it was observed that the fire travelled around the barrier at the aisle face where the commodity extended approximately 4 inches beyond the face of the uprights or vertical barriers.

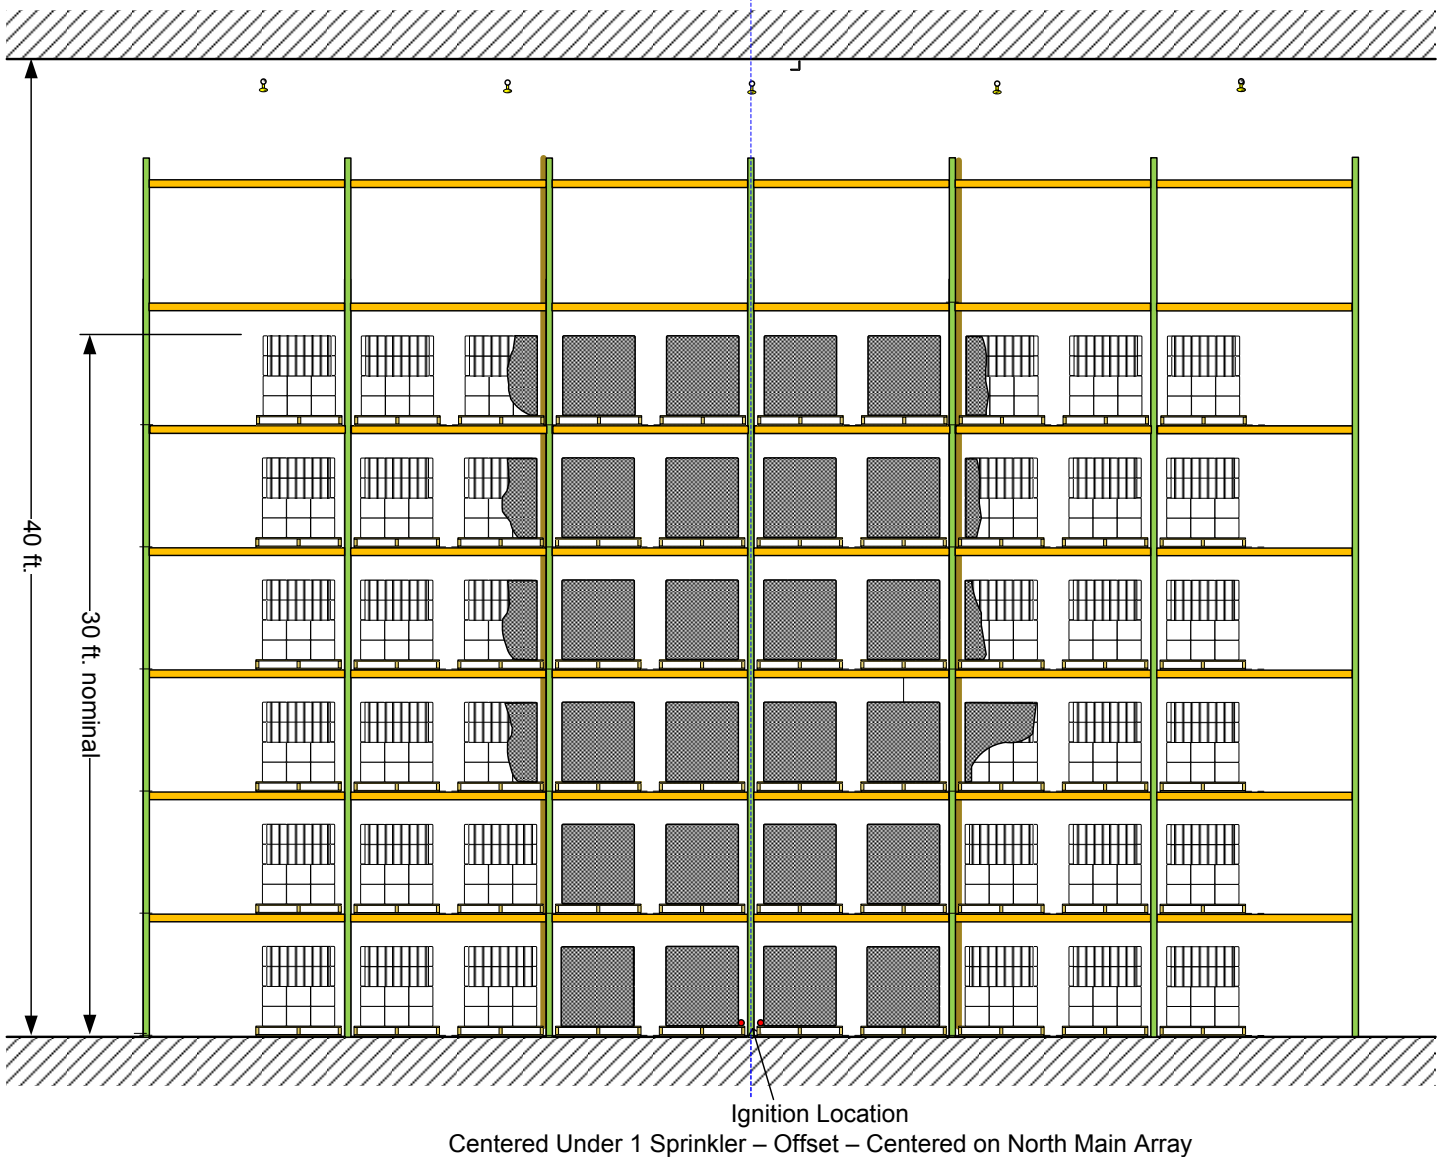
Figure 17 Damage Assessment - Elevation View of North Main Array

In the test, the fire damage extended to a single pallet load beyond the 16 ft. spaced vertical barriers. No target array ignition occurred, however there was partial melting of the exposed surface of the target array across the 8 ft. aisle space.

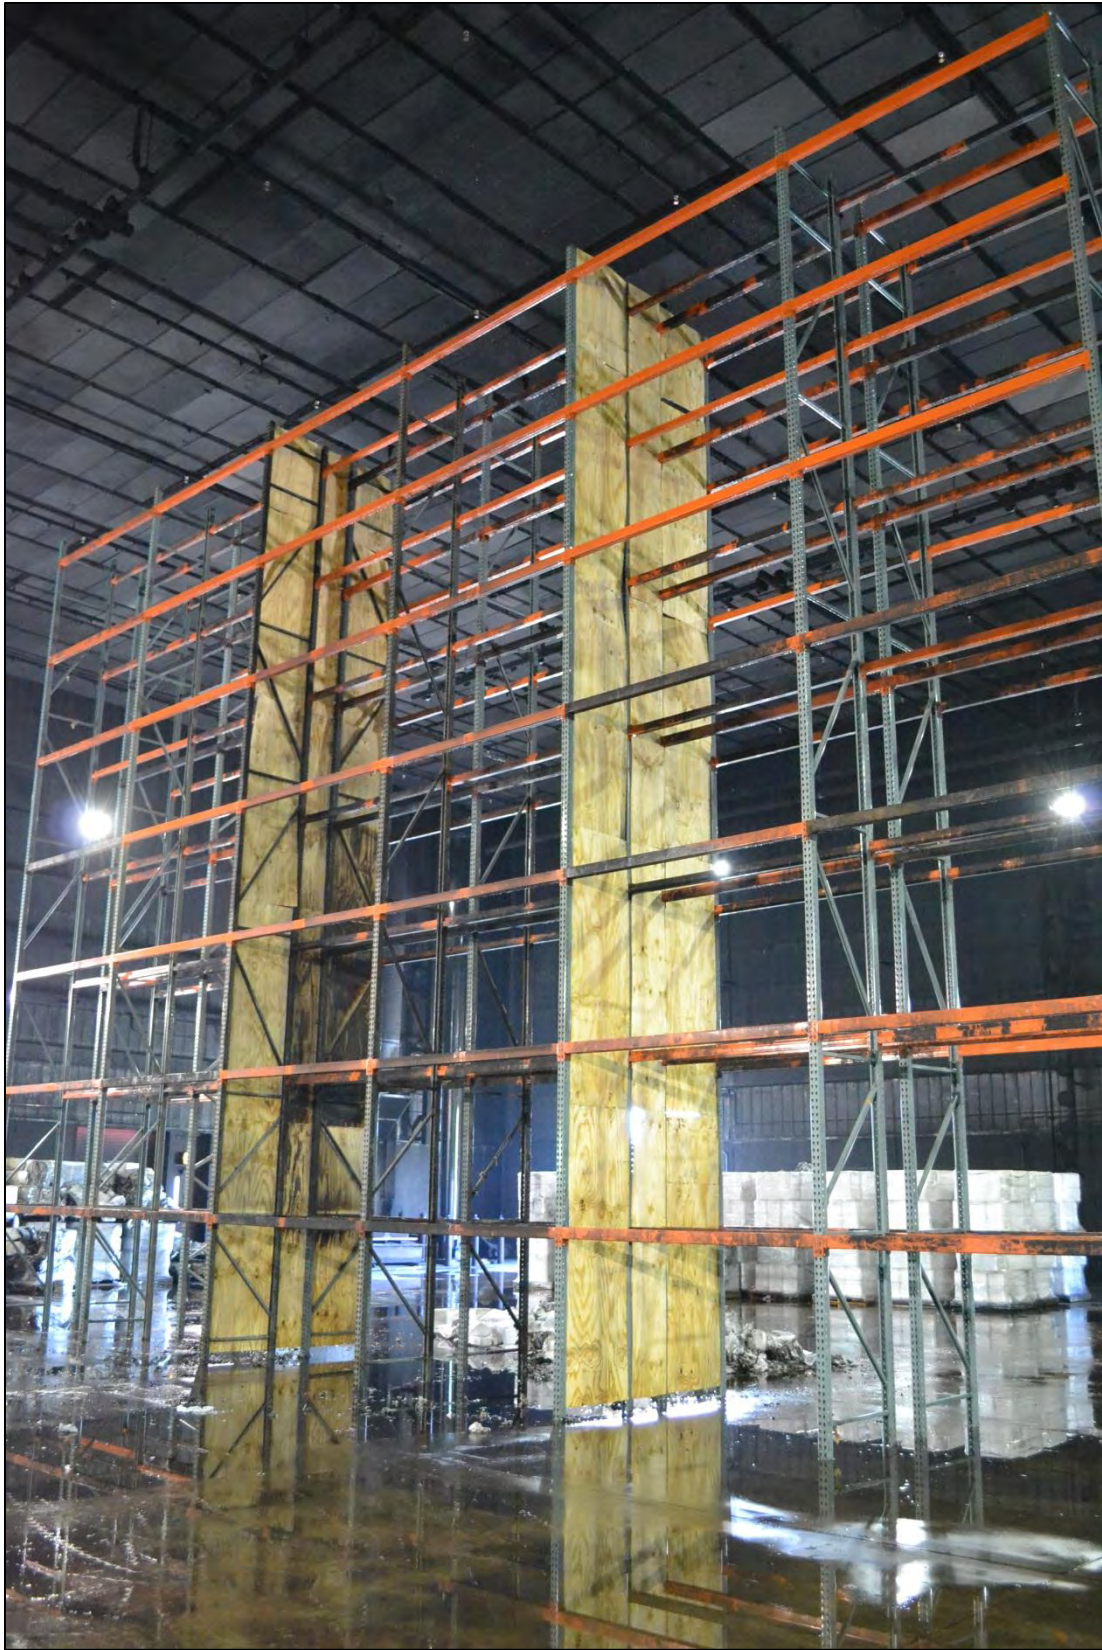
Figure B- 7 View of Combustible Barriers from the Southeast with Commodity Removed

Where breaching of the vertical barriers occurred during the tests, it was observed that the fire travelled around the barrier at the aisle face where the commodity extended approximately 4 inches beyond the face of the uprights or vertical barriers.
